Save Greytown's tree

PUBLIC ENQUIRY: QUERCUS ROBUR DIEBACK

100, West St. Greytown – Heritage Oak Tree

Prepared by: Dave Aitchison N.Dip Arb. NCH Arb.

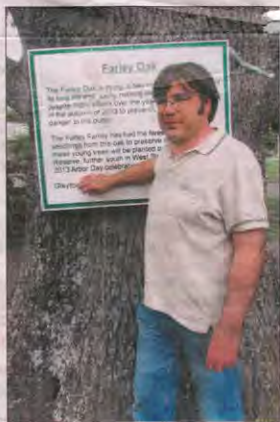
NAMESAKE: Ian Farley at the Farley Oak.

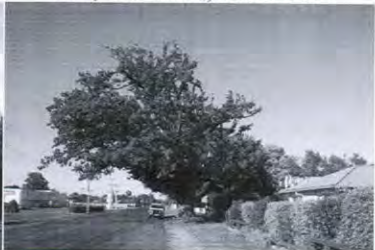
Farleys Oak looking south Feb 2013

The impact of the dieback of this tree is more pronounced on the western side and has the highest visible impact when viewed from the south looking north. When viewed from the north or eastern aspects the visual impact of the dieback and sparse foliage cover is far less noticeable.

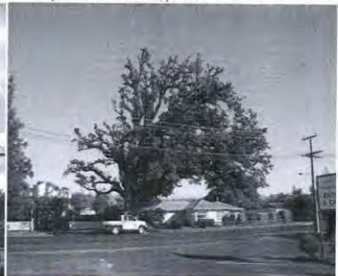
Farleys Oak looking west Feb 2013

The tree displays reasonable form and balance when viewed from the north and eastern aspects but is of very poor form and balance when viewed from the south and west.

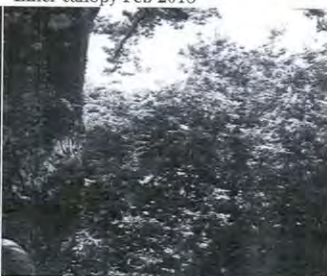
Inner canopy Feb 2013

1. The density of the foliage re-growth from epicormic development particularly in the lower canopy and on the eastern side of the trees crown has increased substantially. This is a compensatory growth form developing as a reaction to the loss of upper canopy growth. The regenerating growth is also found on the main scaffold limbs and pruned back branches where an increase in density is also found in comparison to three years ago.
2. In combination with the increased foliage density, remedial tree surgery has been undertaken to remove the apical deadwood and reduce the crown parameters particularly on the eastern aspect. The impact of this on the overall balance and form of the tree is minimum but overall it does create a more compact crown development. The removal of deadwood has reduced the potential hazard impact and helped to improve its overall visual appearance.
